# Manhole Inspection Summary

Manhole # S31I\_\_003MH

Insp Date: **11/12/08 1:08 PM**

**Location** Address: **s paca st**

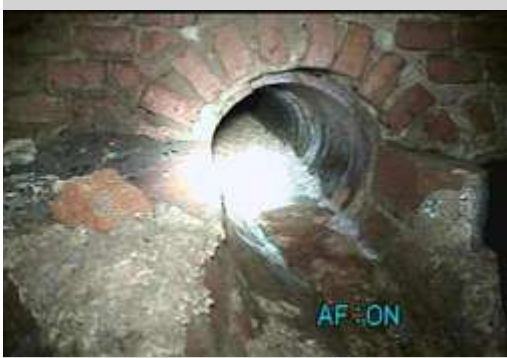
Defect 2

Condition: ☐ Sound ☐ Cracked ☐ Root Intrusion ☐ Deteriorated ☐ Leaks ☒ **Debris**

bench debris

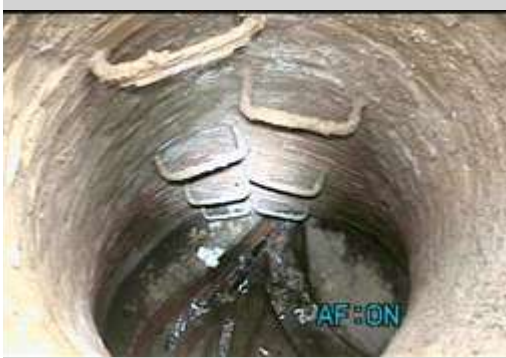
Defect 1

Count: **7** Missing: **0** ☒ **Corroded**

steps corroded

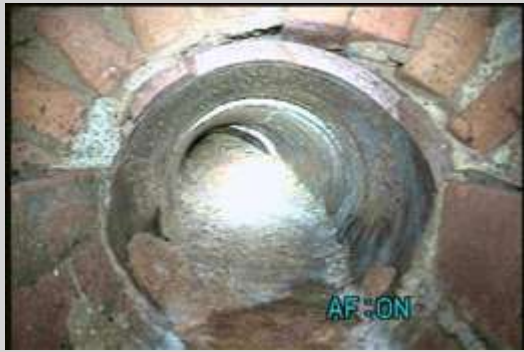
6 O'Clock Inflow

missing grout around pipe

Deposits: ☐ None ☐ Mud ☐ Sludge ☒ Debris ☐ Grease

Silt Depth: 10 (in.) Deposits Extent: Heavy

Infiltration: Evidence Pipe Seal Cond: Cracked

Connects To: Stub connection / abandoned
